STATEMENT OF SIGNIFICANCE

NEACH HILL, DONINGTON, SHROPSHIRE

TDR HERITAGE LTD | MARCH 2021

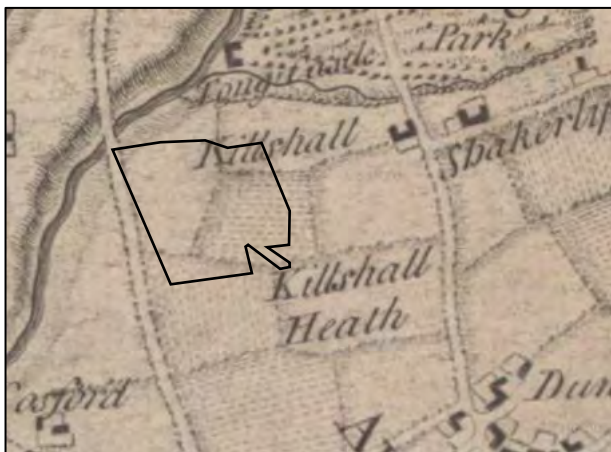
Figure 1: Roque 1752 Actual Survey of the County of Salop (British Library: Map 4900)

The map clearly shows the U-shaped Tong Castle and radiating avenues of its early 18th century park to the north of Neach Hill. To the south of the river it shows the site of the inn at Killshall.

Roque’s map of Shropshire shows the location of the Site as being fields in 1752 (Figure 2) but by 1814, Dawson’s map of East Shropshire shows the Site as containing the principal house, coach house and walled garden, accessed via a long avenue from the newly formed Long Lane, as well as a potential access from the north (Dawson, 1814-17). Access from Neachley Lane is not clearly defined, although there is evidence of some formalised planting in this area.

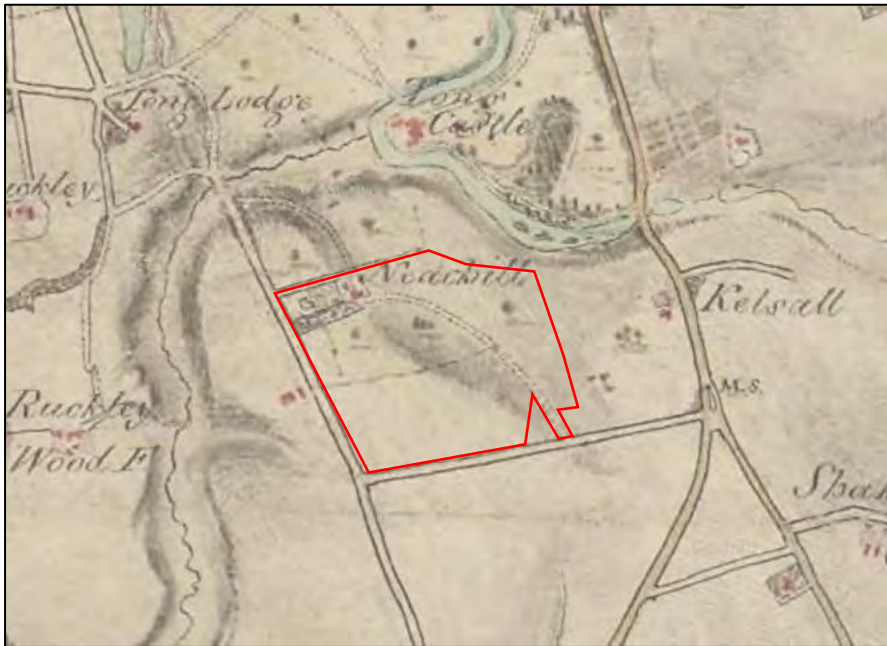
Figure 3: Dawson's Map of East Shropshire and Staffordshire of 1814-17, showing the newly set out Neach Hill with adjacent walled garden and long curving avenue to Long Lane.

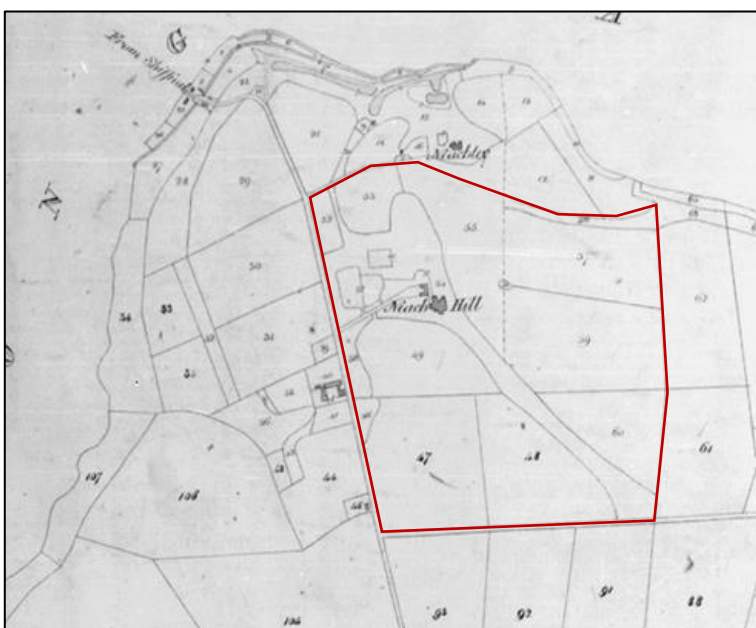
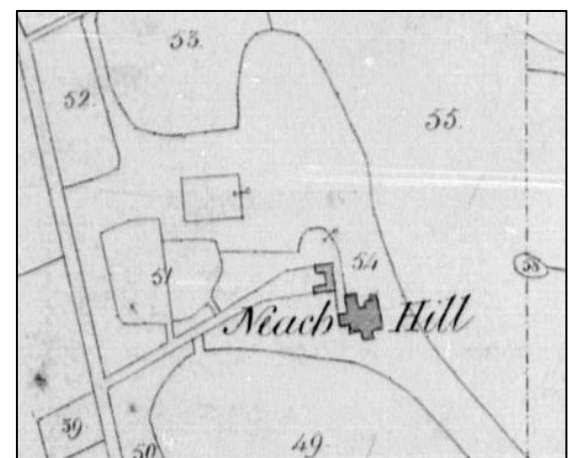
Figure 4: Tithe Map of 1842 showing the site at Neach Hill, with (right) detail of the house and structures in the immediate vicinity of the house (National Archives, IR 30/29/109)

Soon after the sale, the estate at Neach Hill is shown on the Donington Parish Tithe Map of 1842, providing little more detail than the map of 1814-17, but confirming the core components of the original complex and showing the principal house with a portico to the main, southern, elevation, two uneven wings to the rear and a small projection to the western elevation. To the north of the house is a U-shaped coach house, accessed from a service road from Neachley Lane, and a large walled garden shown as a square. A long avenue with a wide entrance provided the main access to the estate from Long Lane (National Archives, IR 30/29/109).

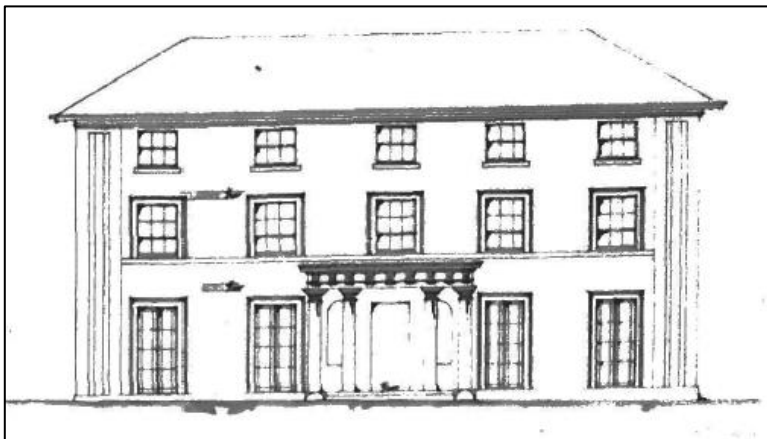
Figure 5: Drawings for W Hatton Esq c. 1870 by Bidlake & Fleeming. Main (south) elevation of the Principal House showing the house in its original form of c1814 and casement/French windows apparently in situ by this date

The drawings from c.1870, illustrate 'as existing' and 'as proposed' details, thereby capturing plans and elevations of the pre-1870 buildings. These 'as existing' drawings show a Classical building of the early 19th century with its principal elevation to the south and comprising a symmetrical elevation bounded by two pilasters, prominent eaves, string courses, and a well proportioned portico carried on four columns at the entrance (Figure 5). To the western elevation, a loggia, which could be contemporary with the original house, is faintly visible (Figure 9).

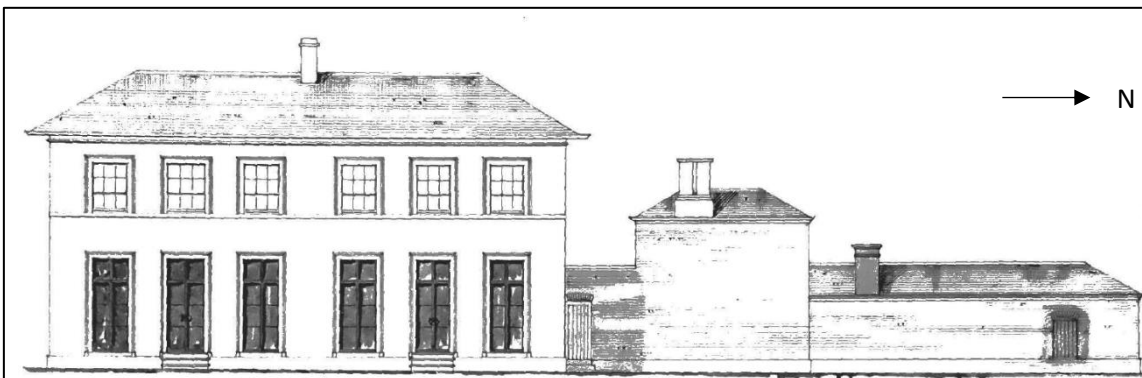
Figure 6: Drawings for W Hatton Esq c. 1870 by Bidlake & Fleeming: 'proposed' East elevation showing the two storey laundry/kitchen wing to the north of the principal house and casement windows and doors to the ground floor.

Whilst a comparison of the Shaw and Bidlake and Fleeming drawings show no discernible change in the appearance of the main (south) elevation, the 'as proposed' drawings for the ground floor windows to the east elevation were shown as being altered to casements, with two of the windows being adapted to doors opening out onto the east lawn (figure 6).

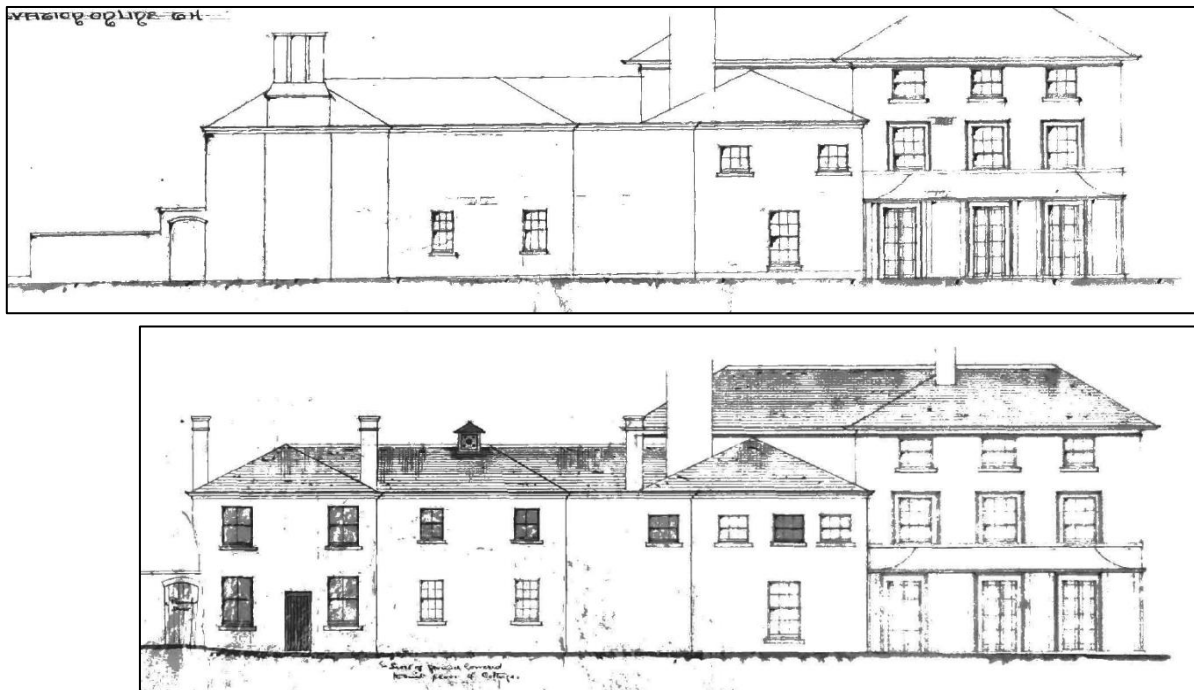
Figures 9 & 10: As Existing and Proposed' drawings prepared for W Hatton Esq c. 1870 by Bidlake & Fleeming: West elevation showing the main house with loggia and a two storey west wing. The proposals incorporated a Billiards Room to the first floor, denoted by a small clock turret or louvered ventilator to the roofline. Proposed alterations are highlighted in grey.

There were also some significant changes proposed to the appearance of the west elevation of the West Wing (shown in grey highlight), including additional fenestration and the creation of a new roof structure above a Billiards Room (at first floor level) to support the addition of a clock turret or louvered ventilator.

In particular, the element to the most northern extent, the servants' hall, which was originally heated by a large external chimney with three flues (figure 9), was proposed to have a floor inserted, the chimney removed and its 18 light sash windows reduced to accommodate a new stair and enable both floors to be lit. Having originally only been entered from the servants' courtyard, these

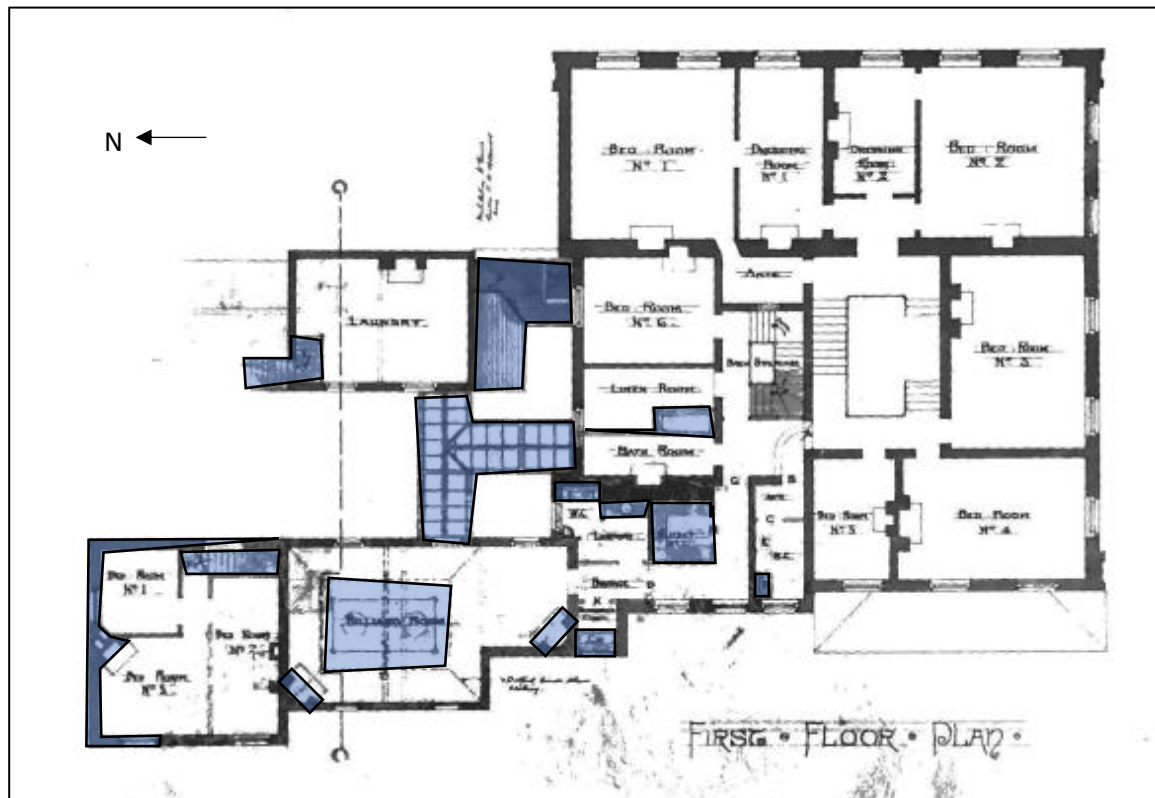
Figure 14: Drawings prepared for W Hatton Esq c. 1870 by Bidlake & Fleeming: First Floor Plan. The proposed elements have been highlighted in blue

The first floor plans of c.1870 show five heated main bedrooms, two with dressing rooms, accessed directly from the main stairwell; a series of service rooms and a sixth, smaller bedroom accessible from the back stairs. A Billiards Room was proposed at first floor level and heated by a large corner fireplace. A further three small bedrooms were accessed via a third internal stair above the servants hall. Five bedrooms are shown in the attic space and four cellars are situated to the front of the main house in the south west corner, all were accessed via the back stairs.

In the basement a barrel run was inserted linked to what may have been three new cellars, and at first floor level a series of rooms were proposed for subdivision to provide bathrooms and water closets.

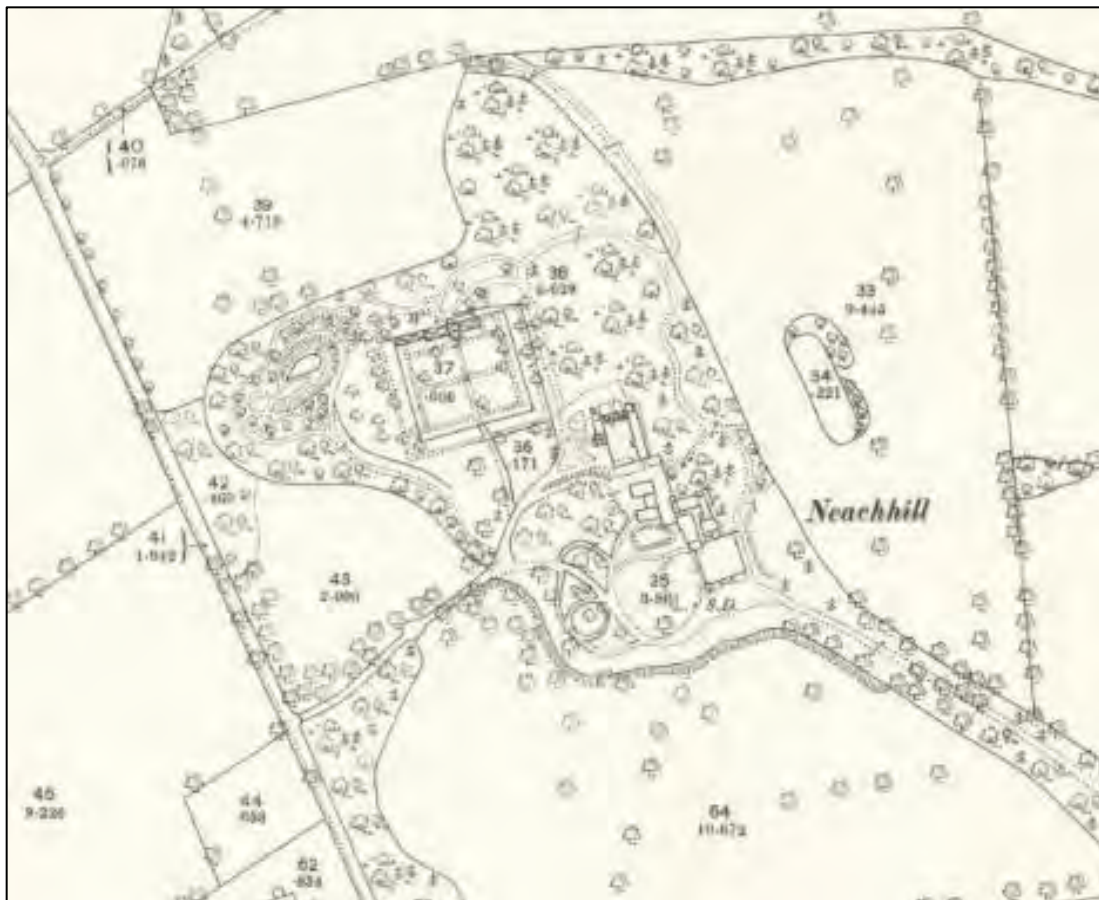
Figure 15: Historic mapping of 1881 showing the house and gardens at Neach Hill in the late 19th century (Ordnance Survey, 1887). Reproduced with the permission of the National Library of Scotland.

The first edition Ordnance Survey map, based on a survey of 1881, clearly shows a considerable number of additions to the estate from those in 1842 (Figure 15). These include extensions to the servants' wings, the development of a range of ancillary buildings, known as Bottom Yard, to the north of the coach house, the addition of a large glasshouse and bothie to the south facing elevation of the walled garden, and a lodge adjacent to the entrance from Long Lane (Ordnance Survey, 1887).

The late 19th century map evidence also shows that the gardens and surrounding parkland had become significantly more structured than in 1842, with a network of curved and serendipitous pathways laid out around the core of the garden. A steep-sided wooded 'dingle' had been created from the remains of a 'marl pit' described on the sale particulars of 1839, planted up and absorbed into the garden design. Mapping shows the dingle with a pond at its base and a circuit of pathways through the area that includes a small round feature in a clearing to the west which may have housed a statue, seat or structure. Elsewhere, a 'knoll' had been formed adjacent to the west wing of the Principal Building, and a sunken lawn created in front of the east elevation. Inside the walled garden was a grid of paths, centred on a feature that may be a fountain, with a main entrance sited on the garden's north-south axis in the northern elevation of the wall (Figure 15).

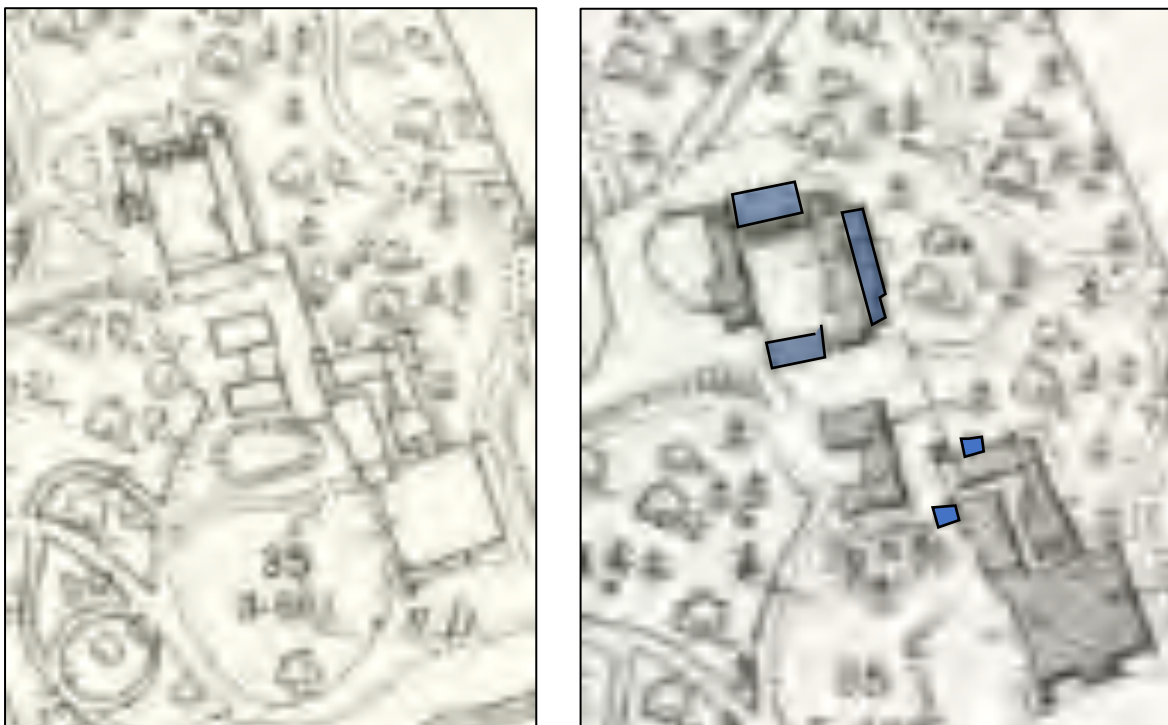
Figure 17: (Right) Ordnance Survey mapping of 1903 showing additions to Bottom yard (in blue), in comparison with (Right) the 1887 map (Left) (Ordnance Survey, 1887 and 1903). Reproduced with the permission of the National Library of Scotland

By 1903 there appears to have been a simplification of the path network, with the removal of a circular feature adjacent to the west lawn, which may have been a rose garden, and the introduction

of a straight linear routeway that cut across the garden from Bottom Yard to the East Park. In the wider landscape there were also some small additions: a change in the fence line in the northern corner of the eastern park, with a structure attached, which was probably for stock management, and a linear structure established just north of the walled garden. At the end of the Avenue the small lodge had almost doubled in size and appears to have a small structure within a defined garden area that relates to half of the property, indicating that it was occupied as two units.

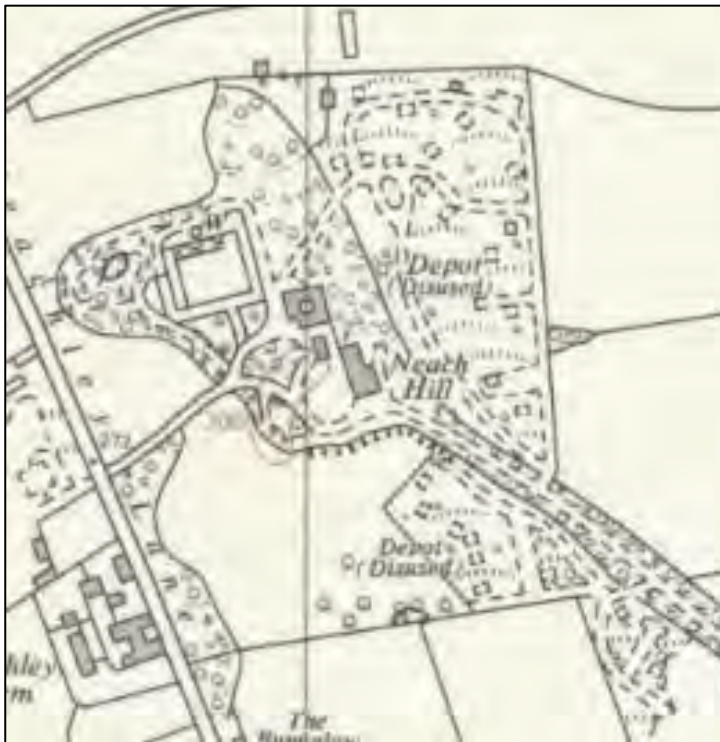
Figure 20: The grounds in 1964, showing the temporary road network, earthworks and structures associated with the world war II depot in the east and south park areas (Ordnance Survey, 1964). Reproduced with the permission of the National Library of Scotland

However, map evidence from 1964 (figure 19) shows the area as a 'depot – disused' and includes upwards of 20 small bomb shelters as well as associated access routes and structures across the east and south parkland areas.

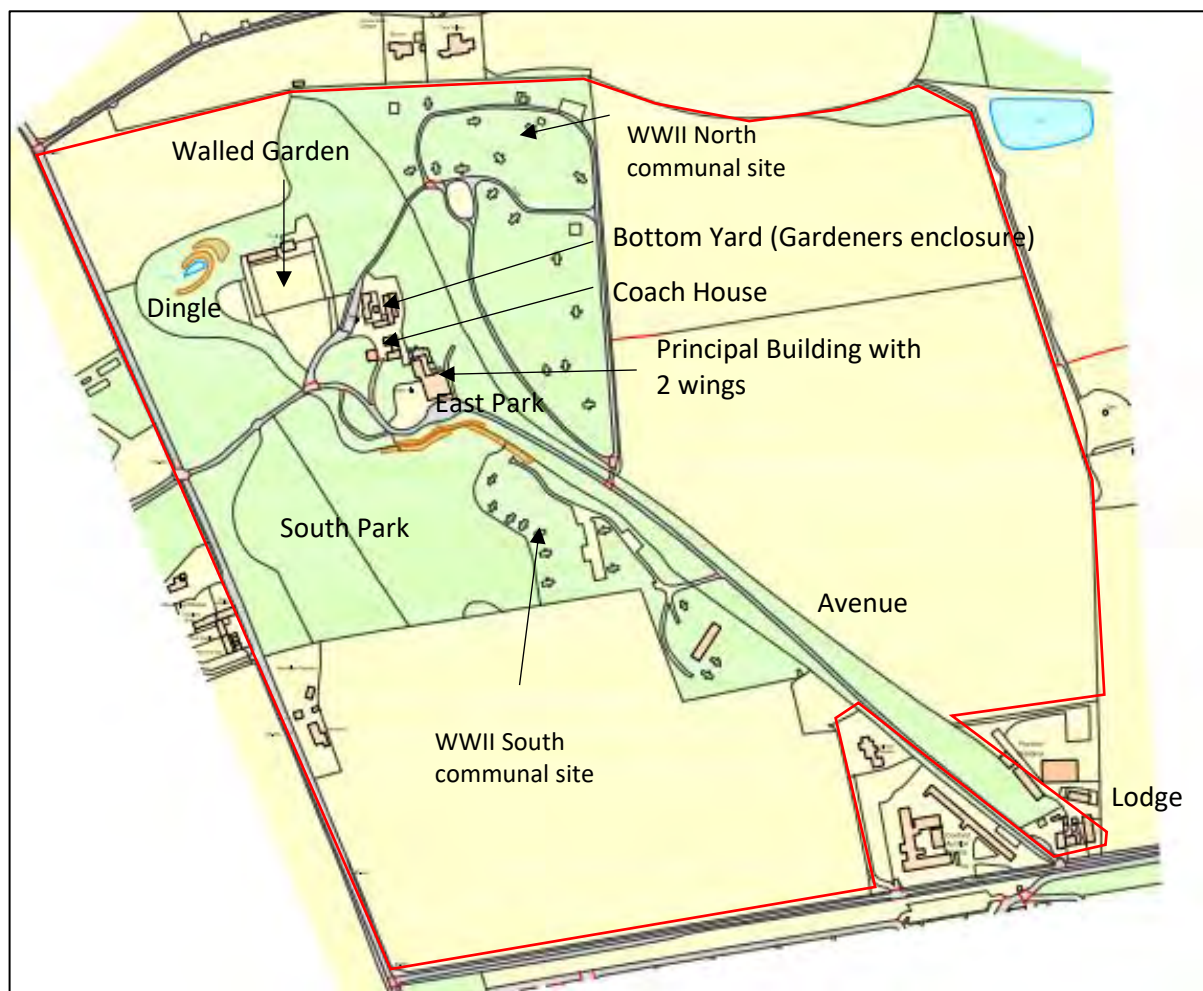
Figure 21: Location map of main complexes, the shaded area shows the extent of the World War II development. (Ordnance Survey © Crown copyright 2021 All rights reserved License number 100022432).

The extant structures and buildings on the site comprise six discrete elements: the principal building and rear servant's wings that principally dates to c. 1814 with some alteration and additions in the 1870s; a U-shaped coach house, seemingly unaltered since c.1814; a complex of outbuildings/farmyard, known as 'Bottom Yard' of late 19th century date, which has undergone substantial alteration and is now largely domestic; the walled garden complex of c.1814, that combines a new dwelling with the remains of a 19th century Bothie; the remains of the WWII/post war structures that occupy the east and south parkland, and finally the lodge which sits at the end of the overgrown avenue.

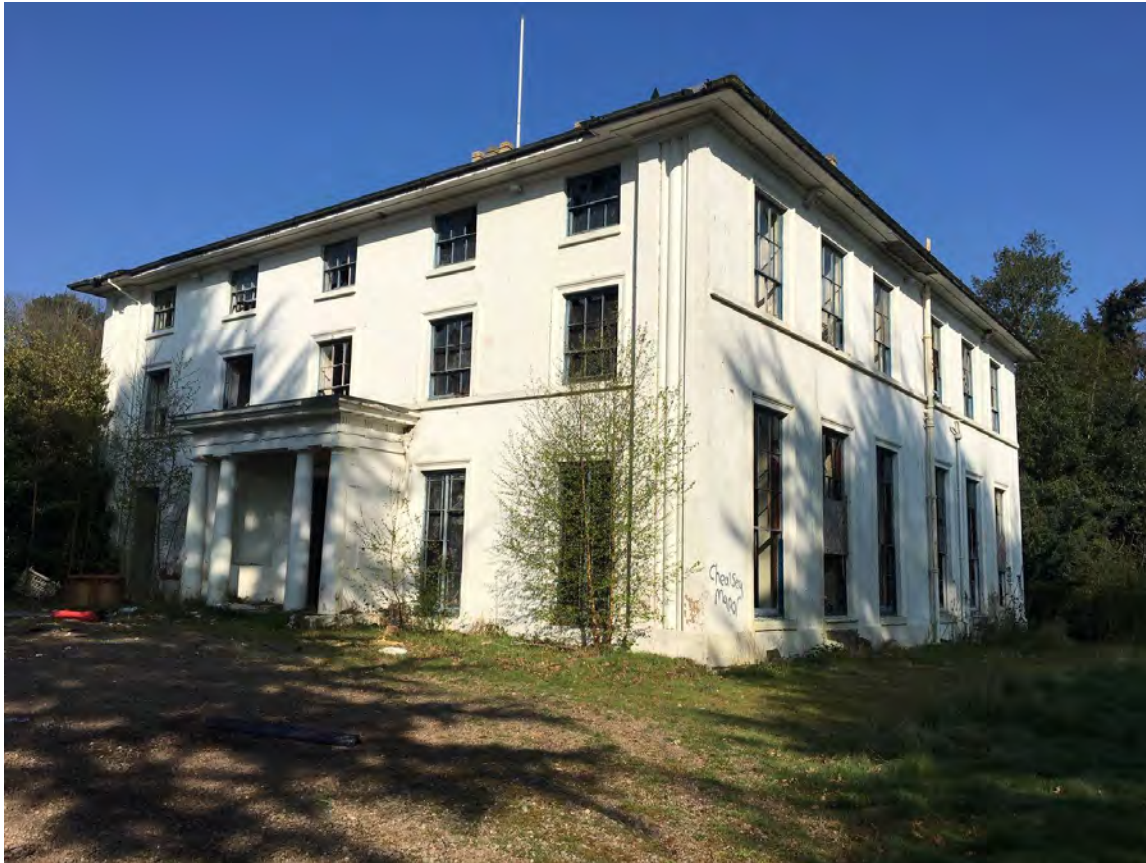
Figure 22: The front and east elevation of the main house prior to boarding up showing casement windows to ground floor of the south elevation and 9/6 sashes to the east elevation

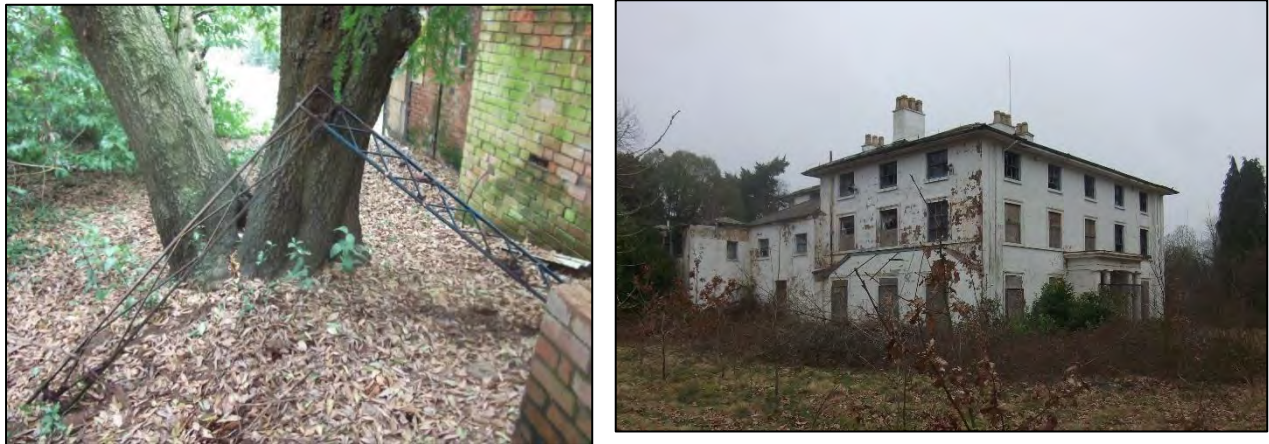
Figure 23: Detail of the Loggia structure (left) and the west and south elevation of the main house showing the roof line (right). Unlike the East elevation, the western elevation comprises a three storey section of 3 windows with an adjacent 2 storey structure

The house is capped by a series of 8 shallow pitched, hipped slate roofs with widespread eaves and a moulded cornice, interrupted by six brick chimney stacks, three on the ridge and three on the structural walls. Most remain only partially intact with the worst of the damage being on the western slope of the east elevation. At the centre of the roof are two light wells, which light the main and back stairs, and which were covered with pitched glass roofs. Only the smaller roof covering the back stairs remains intact.

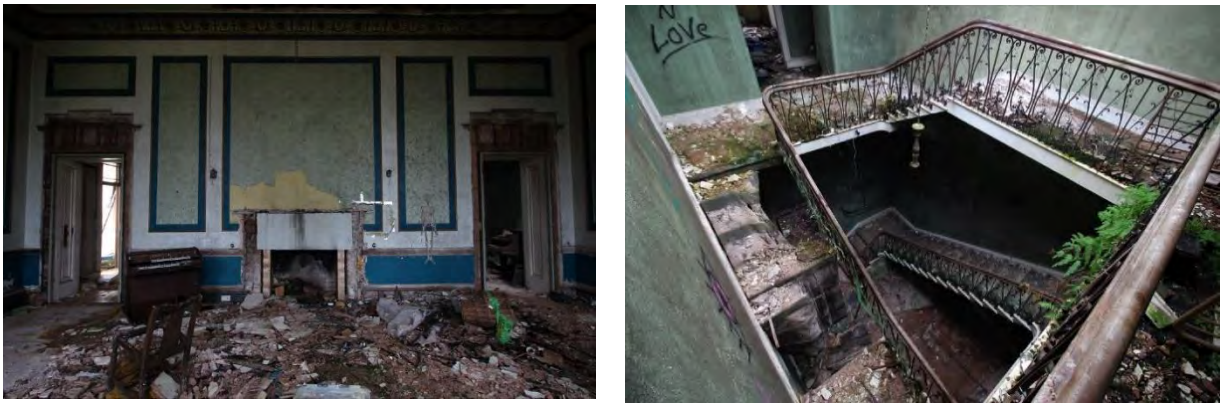
Figure 24: The Drawing room interior (left) and the main stair (right)

Whilst many of the most significant fixtures and fittings, such as door surrounds, fireplaces and mantelpieces, have been lost, especially in the high status ground floor rooms, considerable evidence for internal decoration of the principal rooms appears to remain. The drawing room, for example, has retained its original classical frieze, panelling and dado rail, together with the profile of the door pediment. The physical evidence suggests that much of the interior remained largely contemporary with the original construction of the building in the early 1800s.

Although much damaged, until very recently the central stair had retained its overall appearance and a delicate early 19th century iron balustrade that sweeps down the open-well cut-string main stair (figure 24). Unfortunately drone survey footage from March 2021 shows that the central hall lantern has now collapsed onto the stair causing catastrophic damage, although the elements still remain in situ, apparently relatively unharmed.

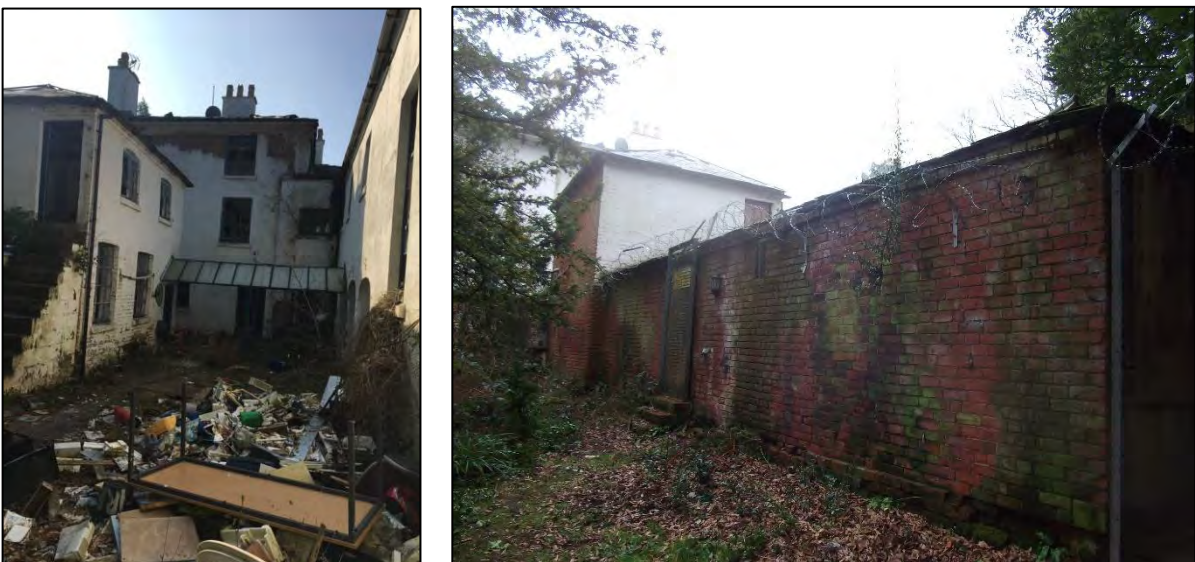
Figure 25: Left: The rear courtyard looking towards the main house. The East Wing is to the left and shows the two storey laundry/kitchen. Right: The east elevation of the East Wing with blocked doorway

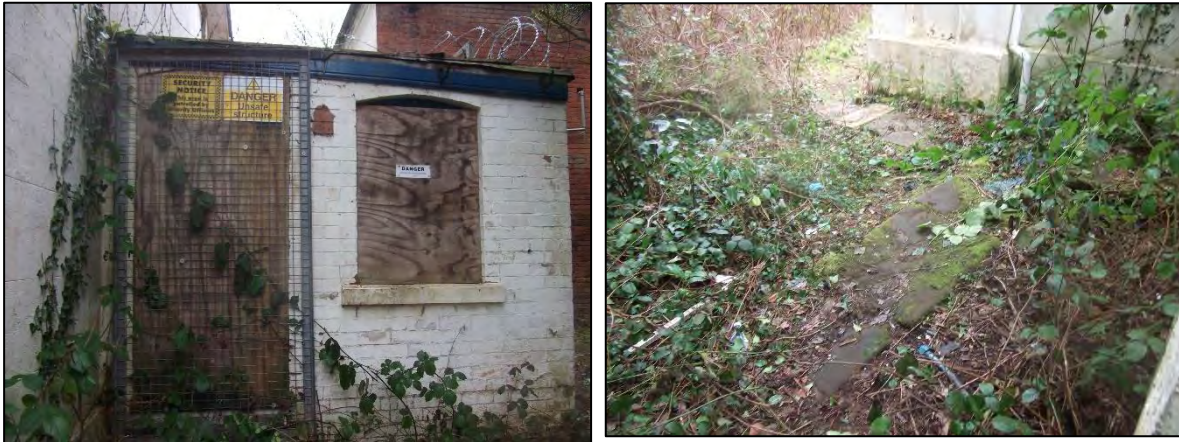
Figure 26: (left) Later addition, possibly serving the garden with (right) evidence of flags or footings in front of it

Building to the east side of the East Wing. This ancillary structure has a brick arched door and window opening to the east and dates to the minor alterations carried out by 1964. It may have provided services to the house or the garden. A series of flags or stone footings were also noted in this area.

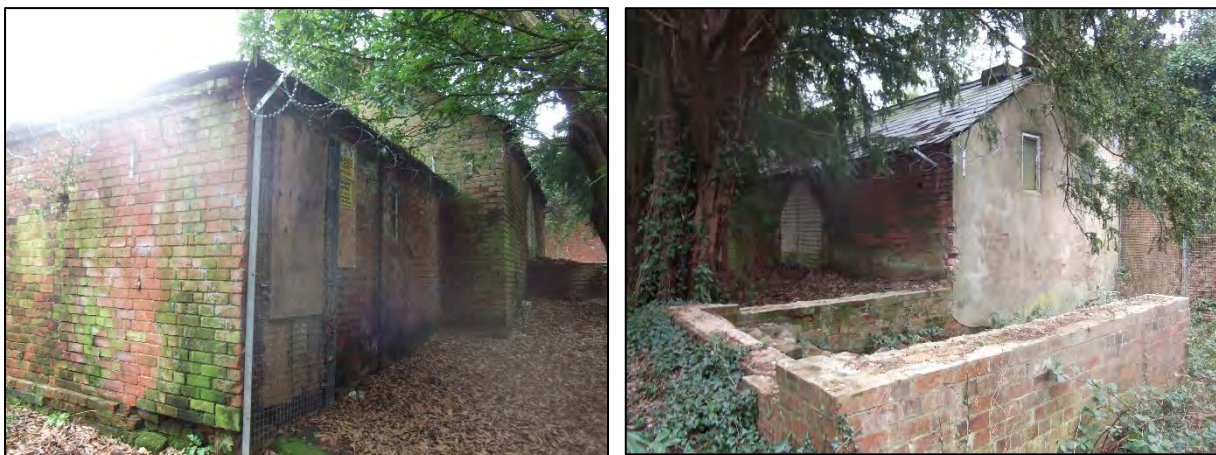
Figure 27: (left) Corner of the East Wing, showing the adjoining single storey structure (right) which forms the northern boundary to the inner courtyard.

The northern end of the servant's courtyard is enclosed by the return of the single storey ancillary building which forms part of the east wing and abuts the gable end of a larger, single storey brick structure. This again has a three course Flemish stretcher bond, but without the eaves detail and a gabled slate roof. The wall to the rear (north) elevation provides evidence for there having been an adjoining brick pitched roof structure (highlighted by a white painted area), now largely demolished and there is a further small brick structure, largely demolished, at its western edge of garden wall bond, probably dating to the 1900s, and linked to the development of the property's service infrastructure. The western elevation is rendered and has a chimney and two single lights at eaves level.

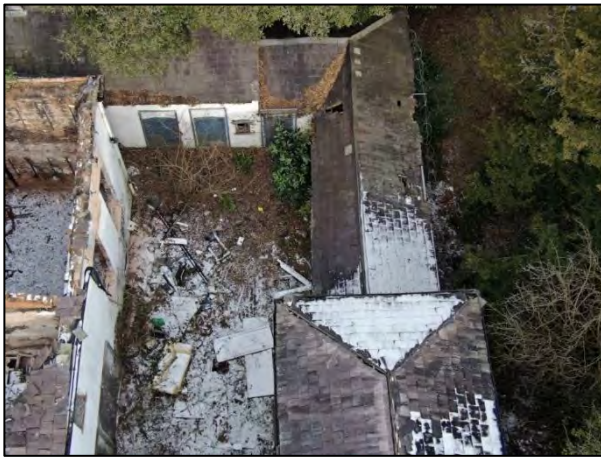
Figure 28: The inner courtyard as seen from above, highlighting the relationship between the West and East Wings and enclosure to the North.

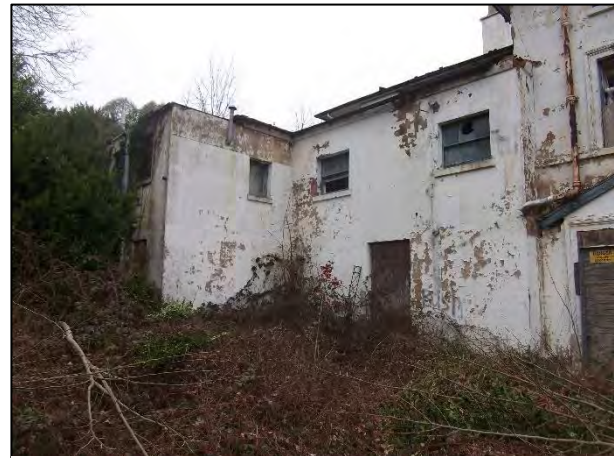
Figure 29: The 2 storey section of the principal building and the projecting bay which housed the Billiards Room to the first floor.

The West Wing is currently not easily accessible but, as noted above, is connected to the corner of the principal building via a shorter two storey stuccoed section. The upper floor /roof structure is in serious disrepair but appears to have been altered in the 1870s as part of work to create an irregularly-shaped Billiards Room to the first floor, and which drawings of c.1870 suggest may have had a small light, louver or clock turret. The billiards room continued into the projecting bay to the north (Figure 14).

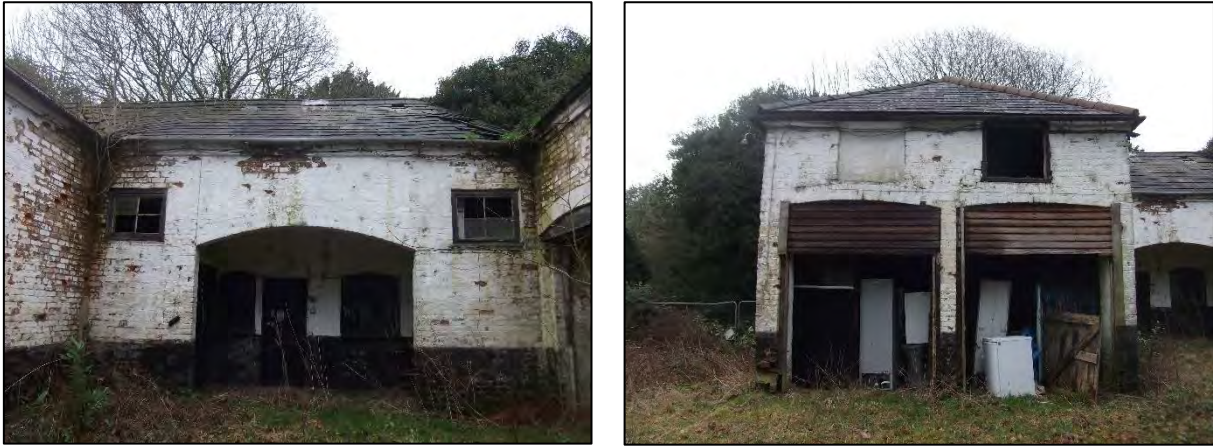
Figure 30: The central section of the Coach House looking towards the east in 2021

The coach house lies to the north of the principal building and is a brick building comprising four brick arched cart openings, with haylofts and pitching holes above. It is constructed in a U shaped configuration with three separate hipped roofs of slate, and has the localised Flemish bond brick constructional characteristics of the original phase. The central block served as a stable and tack room with grooms accommodation above, lit by two square casement windows. Entrance to these spaces was configured under a large brick four-centred archway at the centre of the connecting structure.

The structure seems to have remained relatively unaltered since its construction in the early nineteenth century and retains many of its original fixtures and fittings, although its original guttering has been removed and replaced with plastic.

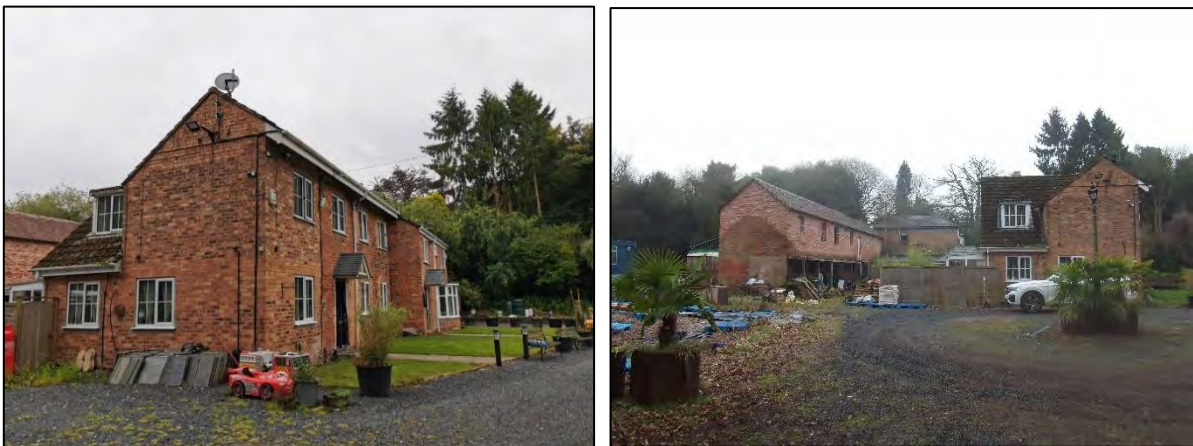
Figure 31: The converted remains of the cowshed into two domestic residences (left) and the Bottom Yard complex, showing the long barn and evidence of the raised roof on its north gable end (right)

The southern range has been almost entirely rebuilt to form a pair of semi detached dwellings, with substantial extensions to their rear, and can be dated to a planning permission granted in 2013. There is partial evidence for the earlier cowshed in the construction of the northern house, where the bricks are of a more consistent darker red and are of the Flemish stretcher bond variation seen in the wings of the main house.

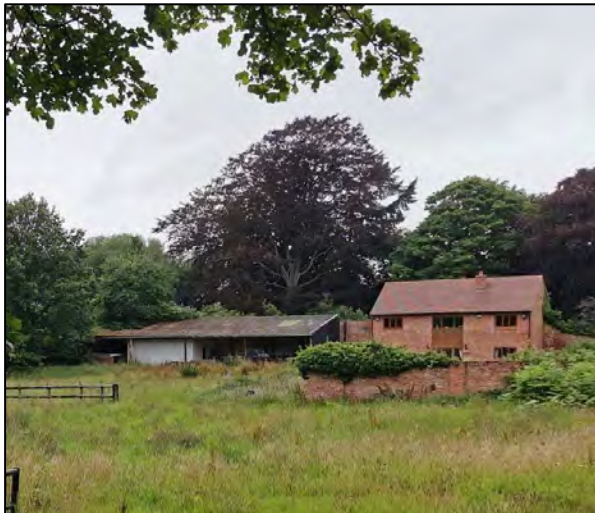
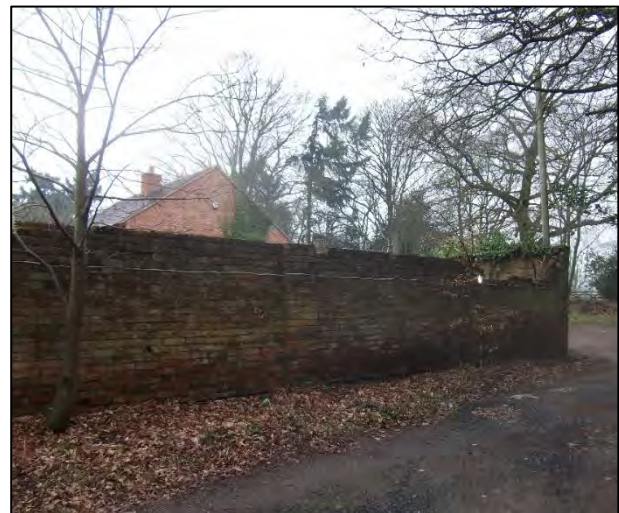
Figure 32: The converted Bothie (left) and the remains of the eastern boundary of the walled garden in 2020 & 2021 (right)

The bothie was adapted and incorporated into a three bedroom dwelling in 1993 and a section of the original building can still be identified as a darker red section in the east wall of the property, constructed in the local version of the Flemish stretcher brick bond, and probably dating to the 1870's.

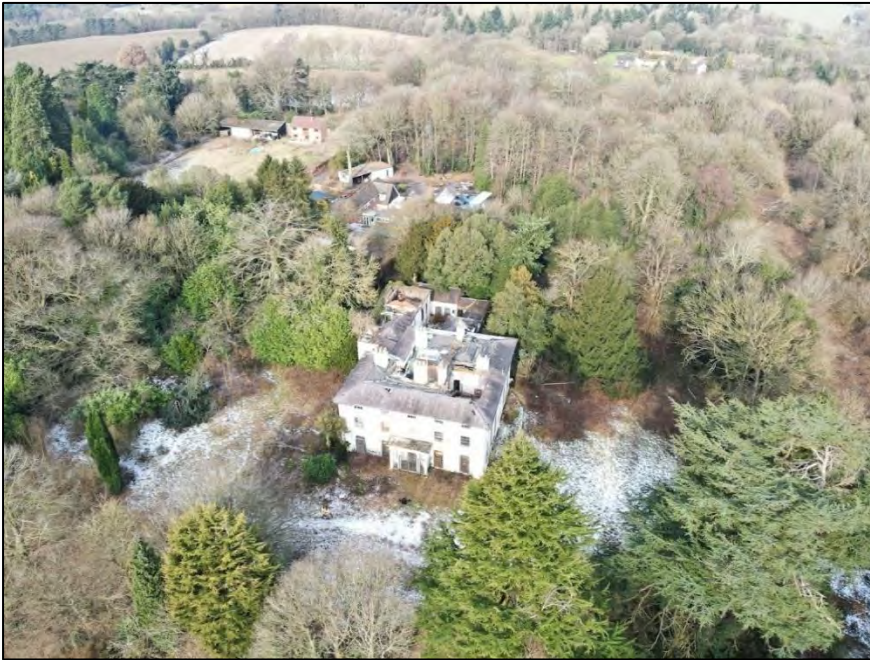
Figure 33: View looking northwards showing the predominance of evergreens of the site, particularly along its western edge

The site is extremely overgrown, and without further survey, a cohesive plan is hard to discern, however there is a density of evergreen trees to the rear of the house, screening the wings, as well as groups formed along the western boundary and around the dingle to the north of the site. Most of the planting appears to be either contemporary with the 19th century construction and

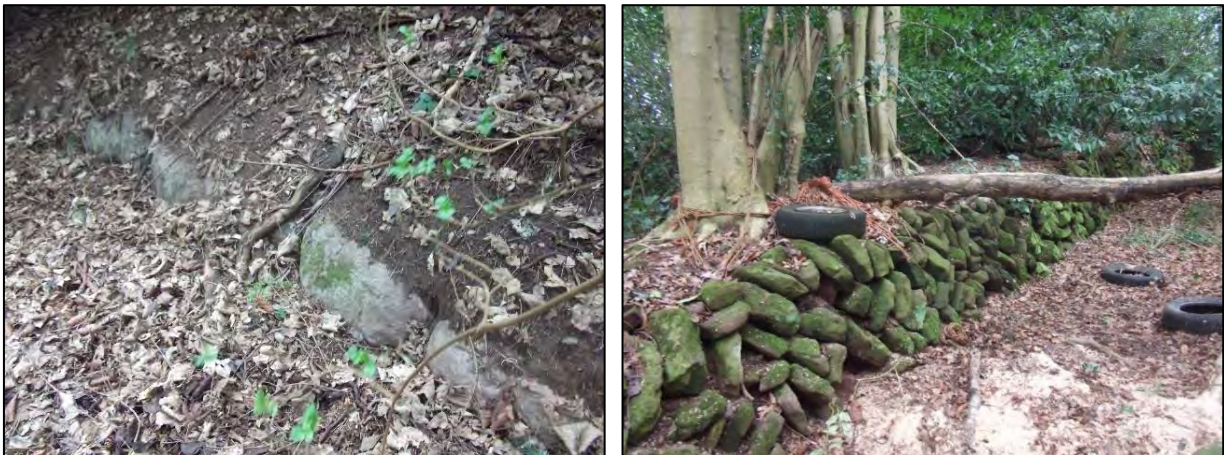
Figure 34: The boulder revetment in the Dingle (left) the stacked stone revetment forming part of one of the sunken pathways through the western part of the garden (right)

The sinuous path network, which is first shown on mapping at in the late 19th century, is still largely extant with some evidence of metalled surfaces, especially along the western edge of the garden. As the house sits on a low rise, the gardens include a series of terraces, especially in the west, as the site falls away to Neachley Lane. The pathways are sunken and have a rustic, Picturesque feel, reinforced by the use of sandstone walls, comprising stacked boulders, as distinct and characteristic edging. This feature is also seen in elements such as banking forming part of the dingle and the base of the knoll.

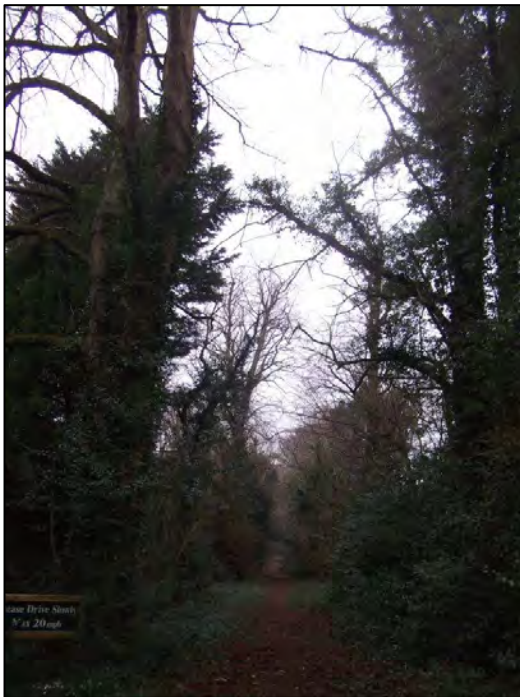
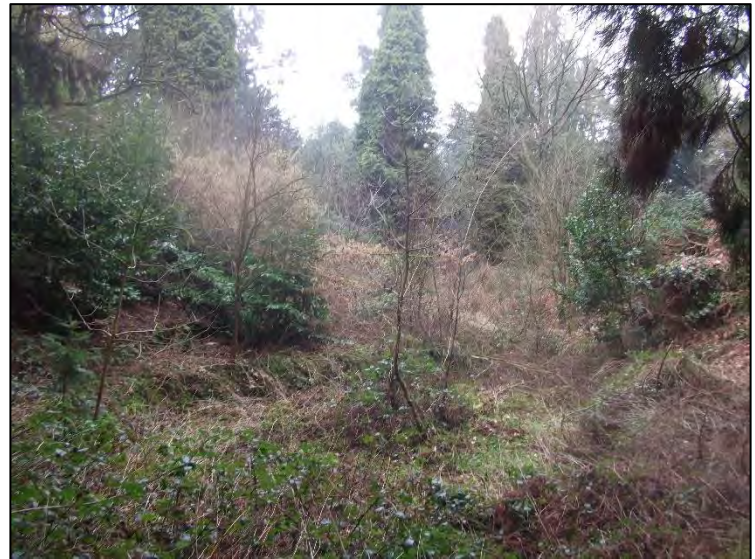
Figure 35: Left: View along the Lime Avenue, looking North and (right) view within the Dingle

Supporting and framing all of these features are the two main approaches to the property from Long Lane and Neachley Lane. These remain strongly visible in the landscape, although the emphasis of use appears to have moved to the back access approached from Neachley Lane in recent times, and as a result, the long avenue is becoming overgrown and more indistinct, with a number of gaps appearing in the formal planting (figure 35).

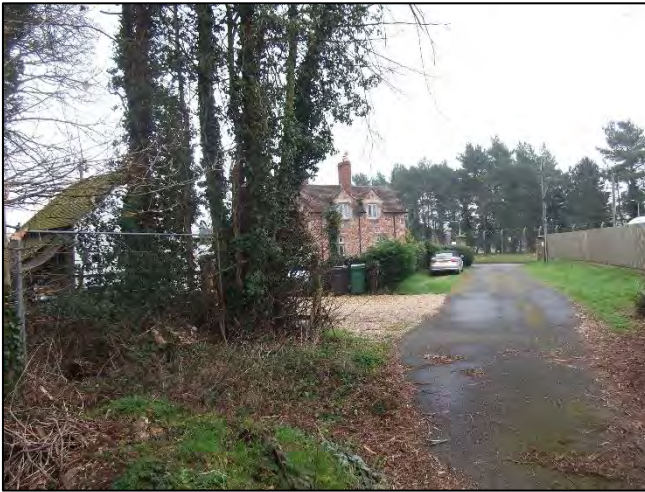
Figure 36: West elevation of the Lodge at the Long Lane entrance, viewed from the Avenue

Situated on Long Lane is a semi-detached domestic dwelling known as the Lodge, which dates from the 1870s. The building is in a rustic irregular red sandstone with alternating blond and red sandstone ashlar quoins and sill and lintel details. Above is a tiled gable roof with a central ridge stack, punctuated by three gabled dormers with square casement windows. At ground floor level there are a further three windows with stone transoms and mullions, each having two lights with individual arched heads. This design is typical of the period and was widely adopted for use in estate buildings in the later 19th century (see Loudon, 1869).

The Lodge has been extended substantially over the 50 years, and is more than double its original size. These alterations are in a style that is in-keeping with the original building but varies in details such as the grain and composition of the walling and the detailing of the windows.

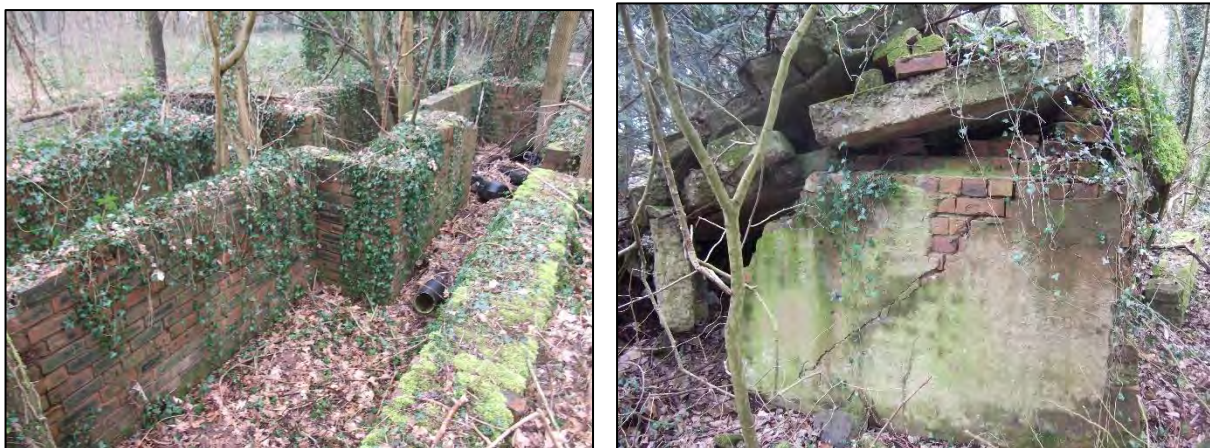
Figure 37: Well preserved remains of an RAF Blast shelter which are still evident in the woodland of East Park (left) and the remains of more substantial above ground structure (right)

The expansion of RAF Cosford, which took place from 1938, included the commandeering of east and south park at Neach Hill for a substantial network of structures. In the East Park, a number of brick and cement rendered structures are still evident within the landscape, some of which are in relatively good condition, masked and protected by naturally regenerated secondary woodland. All of the structures in East Park shown on 1964 mapping are still identifiable on the ground. The most easily recognisable military building is a semi-subterranean rectangular brick structure, accessed at its centre on both sides by brick lined passages, with banked earth to the top of each brick elevation. These are blast shelters that were used to temporarily shelter personnel during air raids (figure 37).

Further south within east park, in line with the main house, are the remains of a building that is clearly of the same fabrication and brickwork as the subterranean military structures, but far more substantial in nature and lies wholly above ground. It is in a very poor condition with only half of it still standing but it appears to be of a single storey construction with a substantial concrete slab flat roof, concrete lintels and in places concrete render (figure 37).
